# What's New for Fort Selkirk?

2018 marked the 31<sup>st</sup> year of a joint project by the Selkirk First Nation and Yukon governments to preserve, protect and interpret the co-owned and co-managed Fort Selkirk Historic Site. All of the planning and activities undertaken at Fort Selkirk are guided by the Fort Selkirk Management Plan, Preservation Plan and Interpretation Plan. These plans have been developed co-operatively by both governments to ensure the mandate for site conservation and management is protecting its heritage values as outlined in the SFN Final Agreement. The implementation of these plans and overall management of the site is overseen by the Fort Selkirk Management Committee. The Fort Selkirk Management Committee is composed of an equal number of members from the Selkirk First Nation and Yukon governments.

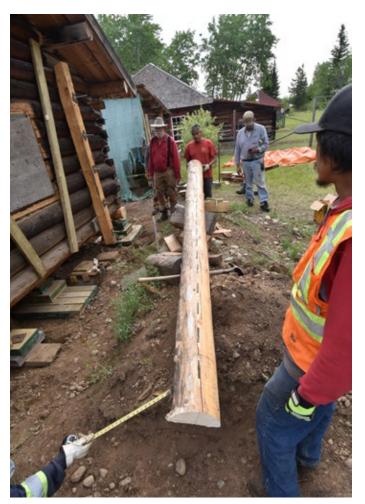
Sill log ready for installation.

Devore cabin lifted, new sill logs being added.

Sill log being notched for door.

The course focused on developing log restoration skills through the hands-on training. It was taught by restoration expert Peter Caron, with additional course support from YG staff. The course was very successful, culminating in the completion of repairs to the Devore Cabin. An additional log building conservation course is being planned for Fort Selkirk in 2019.

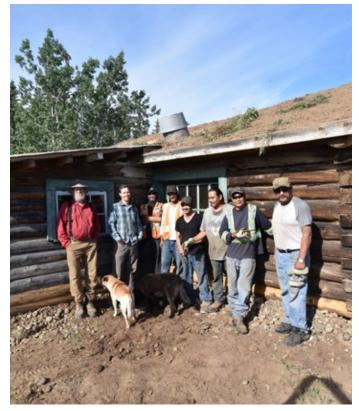
SFN and YG staff in front of competed Devore cabin.

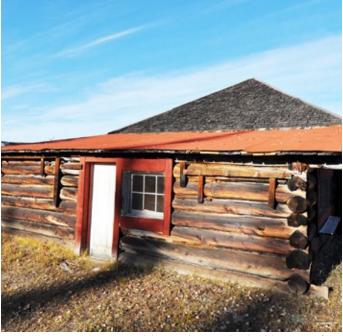
The roof on the shed addition of the R.C.M.P. building had a number of leaks. Some of the leaks were attributed to a failure in the flashing between the main roof and the addition roof. Other leaks were likely due to inadequate overlap between the sheets of rolled roofing. Water stains were visible on the floor, walls and ceilings, with some roof boards showing signs of rot.

R.C.M.P. Building with new shed addition roofing.

The old rolled roofing was removed and rotten boards were replaced. Overlaps between the layers of rolled roofing were increased and roofing cement was applied between the joints. The metal flashing between the two sections of roof were reattached. Following the repair there has been no further evidence of leaks in the shed addition.

The main roof, which is covered with cedar shakes, will need to be re-shingled in the next year or two, as the existing shingles are extensively cracked and cupped.

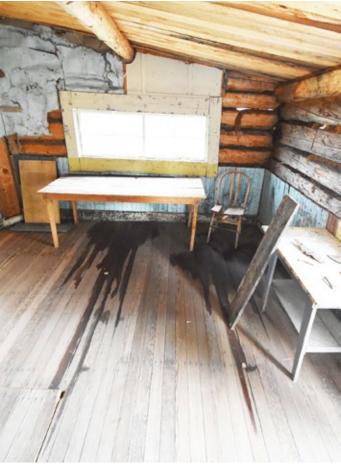
Water stains on the shed addition floor.

The Joe Roberts Cabin has a shed addition located on the west side of the cabin. The shed roof is dirt covered, with a waterproof membrane (EPDM) underneath the dirt to prevent moisture from damaging the underlying roof poles. A two to threeinch gap was present between the shed roof and the main cabin. Although this gap was located beneath the eaves of the main cabin roof, rain and dirt were still coming in though the gap. To fix this, a length of waterproof membrane was installed down the outside of the cabin wall, beneath the eaves, and underneath the main sheet of waterproof membrane on the shed roof. The waterproof membrane cannot be seen from the ground and has no visual impact on the roof. This repair will keep the Joe Roberts cabin dry for many years to come.
